# Bearing damage and failure analysis

# Contents

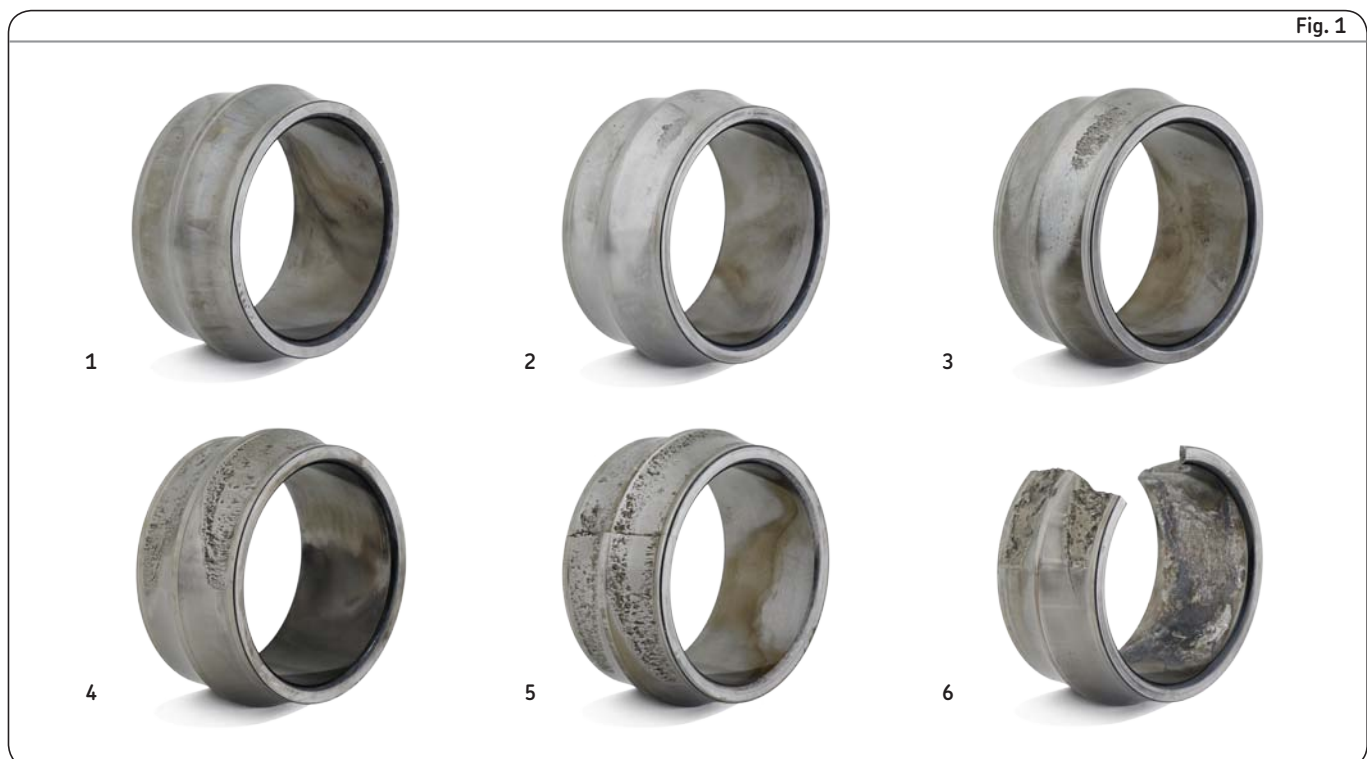
**Fig. 1** shows the progress of damage as illustrated in **diagram 1**:

- 1 Bearing exhibits incipient abrasive wear.
- 2 First spall, detected by SKF enveloped acceleration technology.
- 3 Spalling has developed to an extent that the damage can be detected by standard vibration monitoring.
- 4 Advanced spalling causes high vibration and noise levels and an increase in operating temperature.
- 5 Severe damage occurs: fatigue fracture of the bearing inner ring.
- 6 Catastrophic failure occurs with secondary damage to other components.

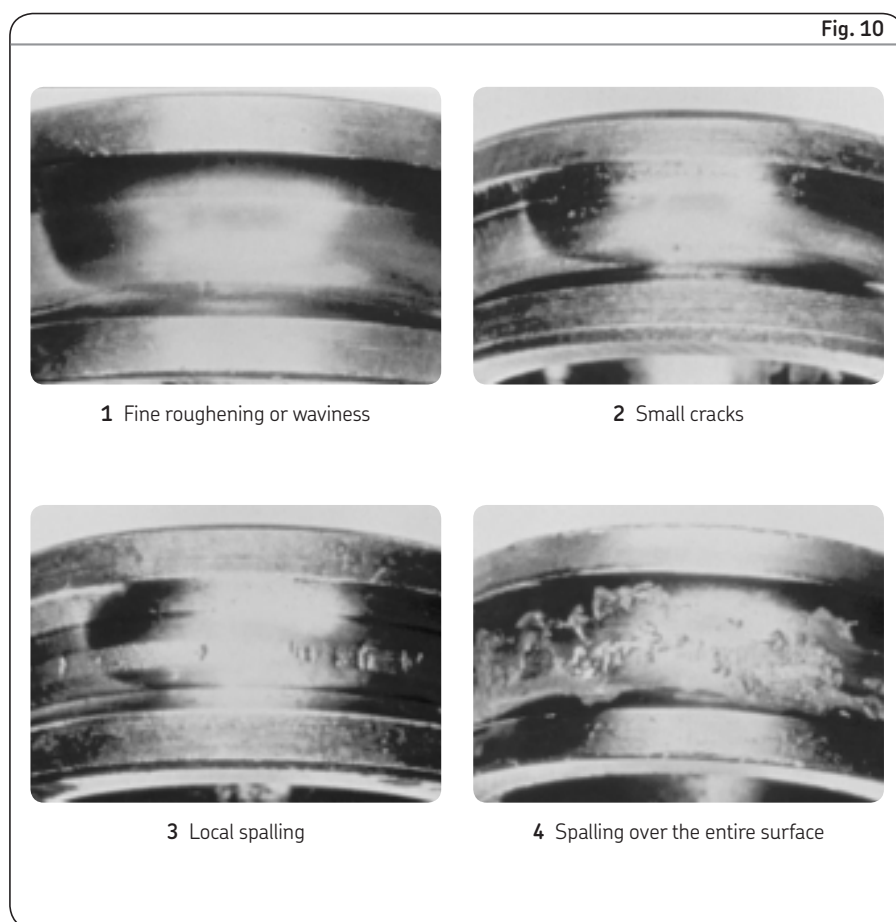
*Progress of surface initiated fatigue on the inner ring of a deep groove ball bearing*

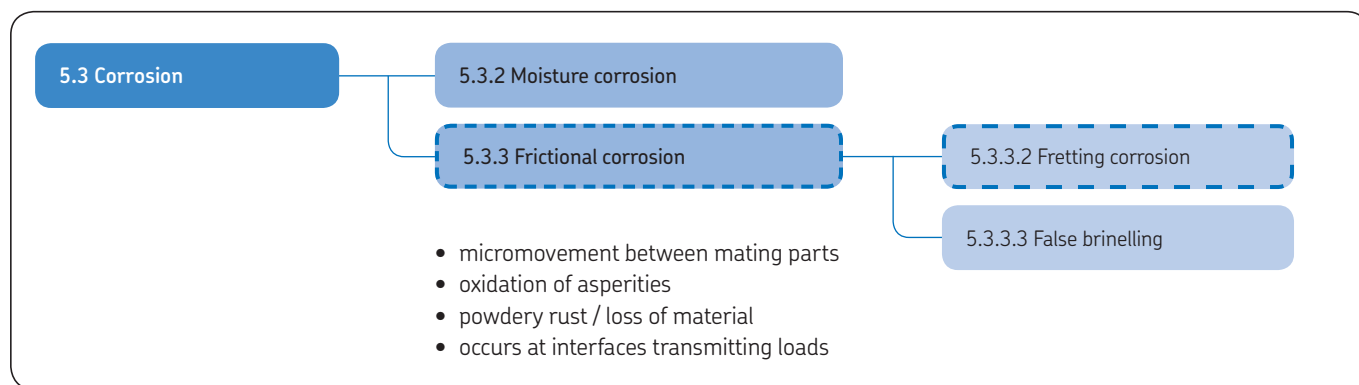
Schematic view of different stages in development of fretting corrosion

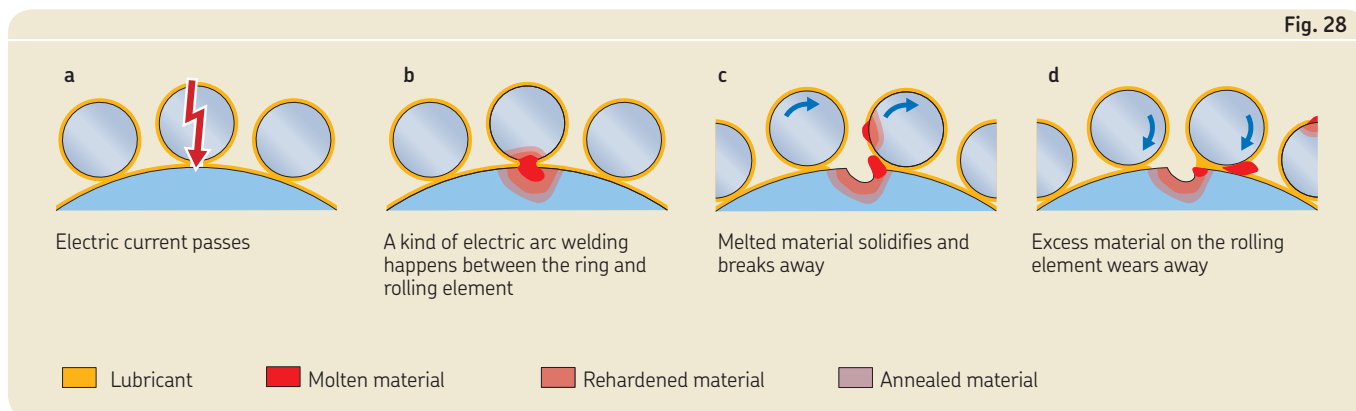
- progressive removal of material
- high current: sparking
- localized heating at extremely short intervals: melting/welding
- craters up to 0,5 mm

#### Mechanism of excessive current erosion

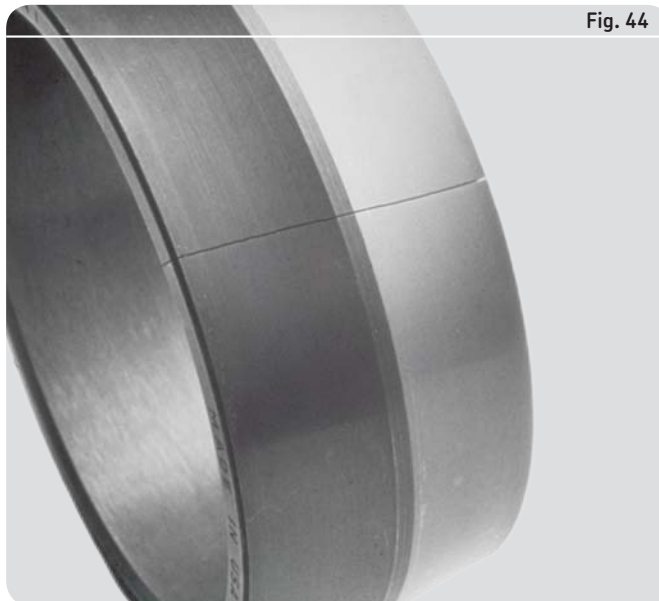
Fig. 44

*Fracture on the large shoulder of a tapered roller bearing inner ring resulting from rough treatment*

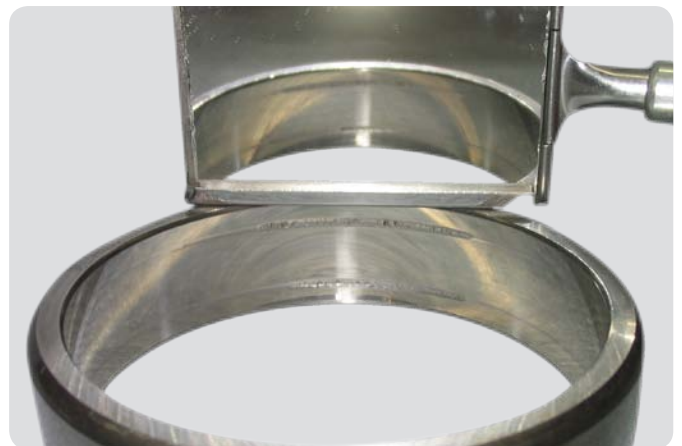
**Tapered roller bearing inner ring**  
Spalling on one side of the raceway only, resulting from misalignment and consequent edge loading, leading to higher stress and failure

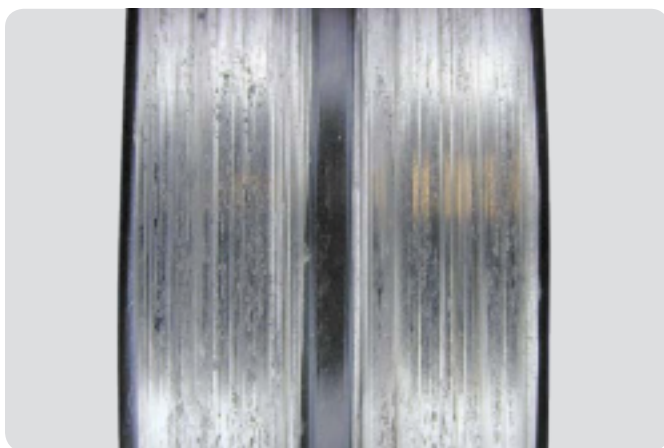
**Spherical roller bearing outer ring**

Abrasive wear of the cage pockets due to inadequate lubrication and vibration. Cage bars worn away.

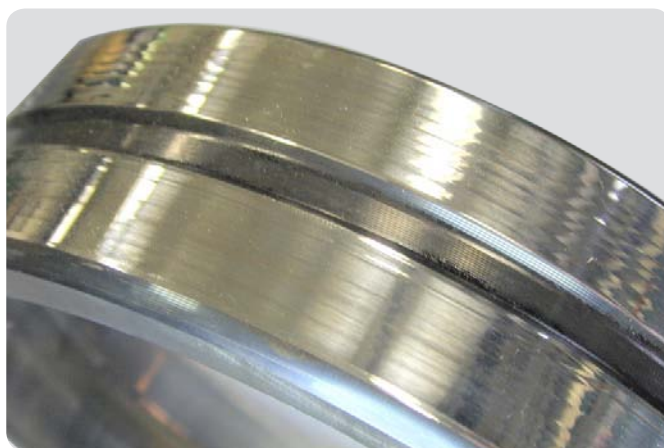
**Spherical roller bearing outer ring**

Ring creep in the housing from inadequate fit – abrasive wear marks on the outside surface

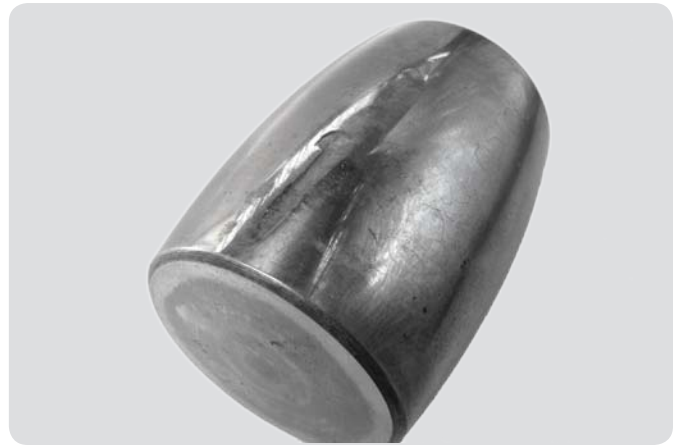
**Spherical roller thrust bearing – roller**  
Heavy impact, plastic deformation

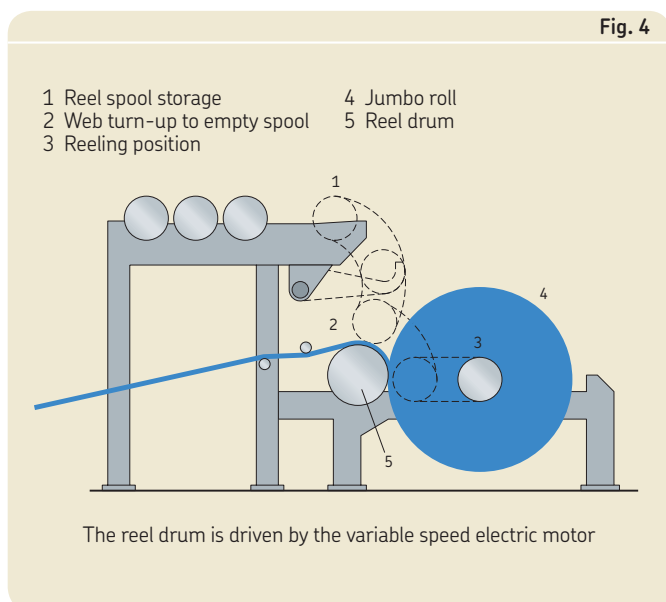
Fig. 4

### Typical layout of a Jumbo roll (reel spool)
